## **Construction Focus Four: Caught-In or -Between Hazards Student Handouts**

# ACCIDENT REPORT FATAL FACTS

## ACCIDENT SUMMARY No. 5

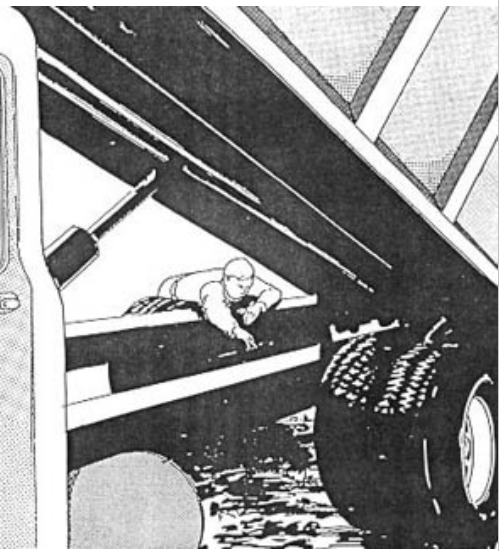
<b>Accident Type:</b>	Crushed by Dump Truck Body

A truck driver was crushed and killed between the frame and dump box of a dump truck. Apparently a safety "over-travel" cable attached between the truck frame and the dump box malfunctioned by catching on a protruding nut of an air brake cylinder. This prevented the dump box from being fully raised, halting its progress at a point where about 20 inches of space remained between it and the truck frame. The employee, apparently assuming that releasing the cable would allow the dump box to continue up-ward, reached between the rear dual wheels and over the frame, and disengaged the cable with his right hand. The dump box then dropped suddenly, crushing his head. The employee had not received training or instruction in proper operating procedures and was not made aware of all potential hazards in his work.
